# TREE SAFETY APPRAISAL

Land opposite 1-8 Royal Victoria Court, Royal Victoria Place,  
Bristol BS10 6TL.

Clients; BPDML Admin Centre, on behalf of Brentry Park Development  
Management Company Ltd Issue date: 15/03/2024

AJE/29526 Rev1

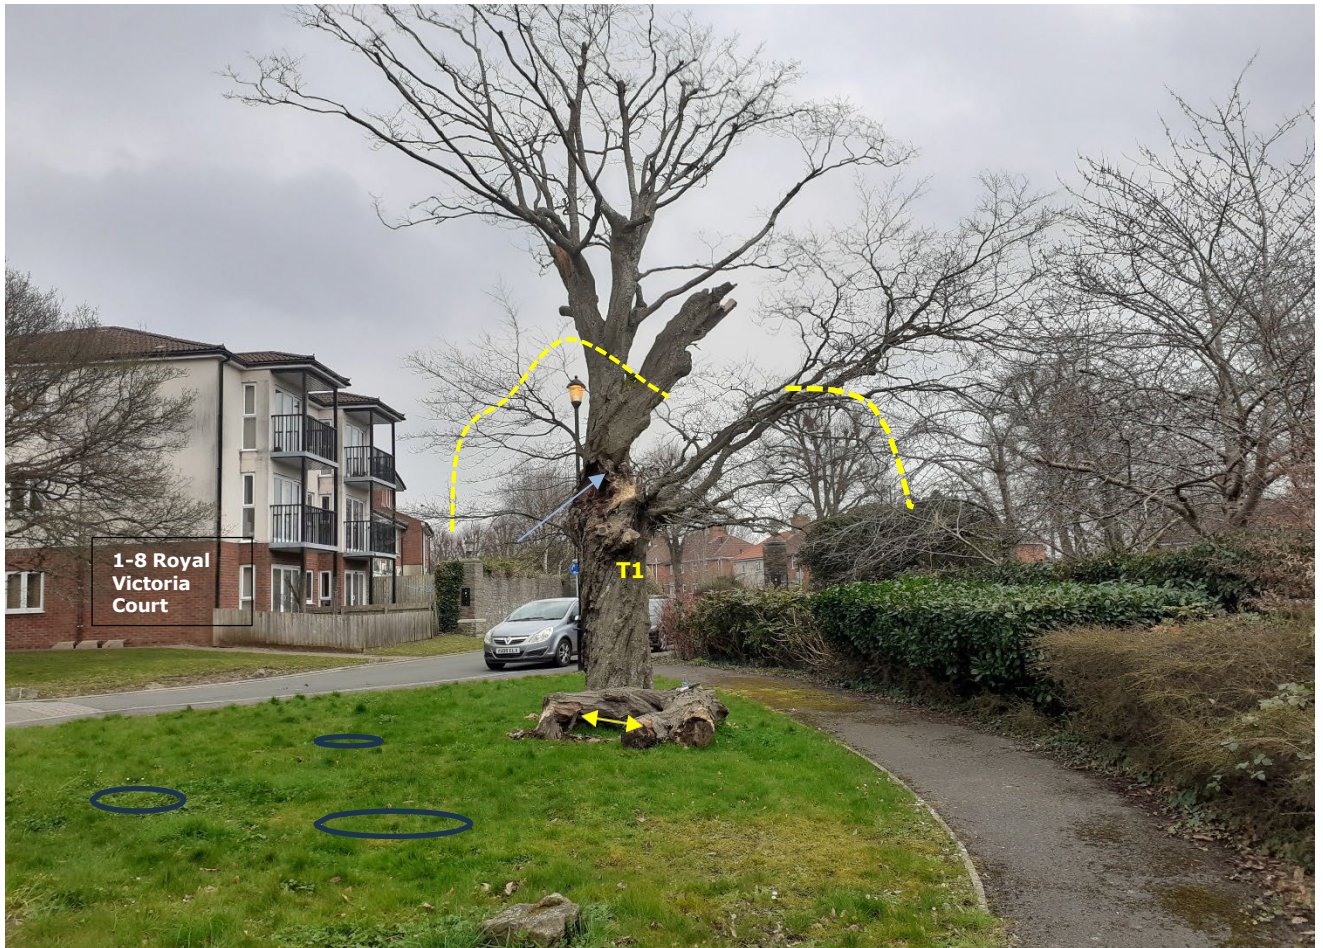
Viewed facing North-Northeast towards tree T1, with Charton Road out of view behind the hedge and young tree plantation to the right of the picture. The two fallen dead stumps (Yellow arrow) have no live growth, they fractured out from the principle trunk fork, light-colored breakage position (Blue arrow). For maximum net biodiversity gain, the wood and brush chippings are best left on site, close to T1. Note the proposed pruning cut positions, (yellow dash lines) and x3 possible long-term planting locations, (Blue ovals) needed to provide continuity of tree cover in this part of the conservation area.

- 1.1 This report is requested by the clients following tree safety and maintenance correspondence concerning a Hornbeam, *Carpinus betulas* (T1 of the tree location plan TLP) growing within the landscaped grounds above; it is a large decaying specimen that recently shed a dead, forked 45cm diameter limb, **(Page 1 picture)** of significance to safety and is increasingly vulnerable to further collapse. The tree safety appraisal and maintenance recommendations are below.

- 4.1 The overmature/near veteran T1 has a height of circa 12m, crown radial spread of 5m, trunk diameter of 78cm. The trunk buttressing is decayed for about 1.8m of the trunk circumference, with a southerly facing 25 cm diameter sporophore within the southerly indent, next to functioning, upward spiraling, live woundwood development, overlaying a hollowing trunk, up to a group of near-horizontal, healthy, ascending branches, growing around the recent fracture point at about 3m above ground level **(Page one picture)**.

- 4.2 On the northerly side of the trunk at about 1.4m height, are two old 3.5cm diameter rounded sporophores, above which are four, fully mature, blackened 'hoof' shaped' 50cm diameter sporophore brackets of *Ganoderma adspersum/applanatum* a serious wood decay fungus, adjacent to the recent breakage position, where the wood supports the upper trunk and a very sparse higher crown.

- 4.3 Combined with my binocular inspection, and mallet trunk sounding, I expect the trunk heartwood to be extensively decayed and the upper branches weakly attached to the trunk.

- 4.4 Effectively, trees do not 'heal', but the healthy, spiraling upwards trunk growth is 'retrenchment development', where the tree will form a new lower canopy supported by thick, solid wood growth, around the hollowing trunk, providing pillar-like support; the low new crown, could then be cut back to the original pruning points, **(Page one picture)**, with consent from the Council, on say 5-year return visits.

- Reduce the upper trunk to just above the secondary fork divide, cuts about 70cm diameters, shorten the healthy southerly branches in vertical alignment with the footpath join with the laurel hedge, cuts 2-12cm diameters, shorten the easterly outer low foliage by 2.5m, cuts at 1-3cm diameters.
- Plant x3 Hornbeam in the grassed area close to T1, the precise species, planting positions and sizes could be the subject of agreement between the client and Council.
